Phase I Environmental Site Assessment

**5040 Firestone Blvd.,
South Gate, CA**

August 9, 2005

Site Name: **Piazza Trucking**

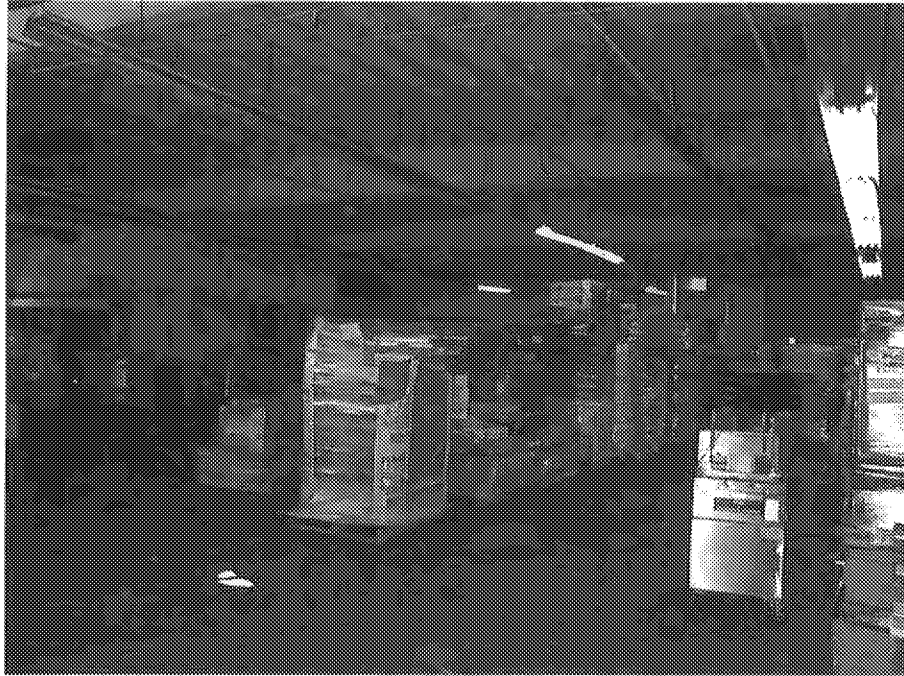
Photograph No. 1 – The subject property is improved with a single-story, light industrial building that is currently used for storage. The building was constructed in 1962.

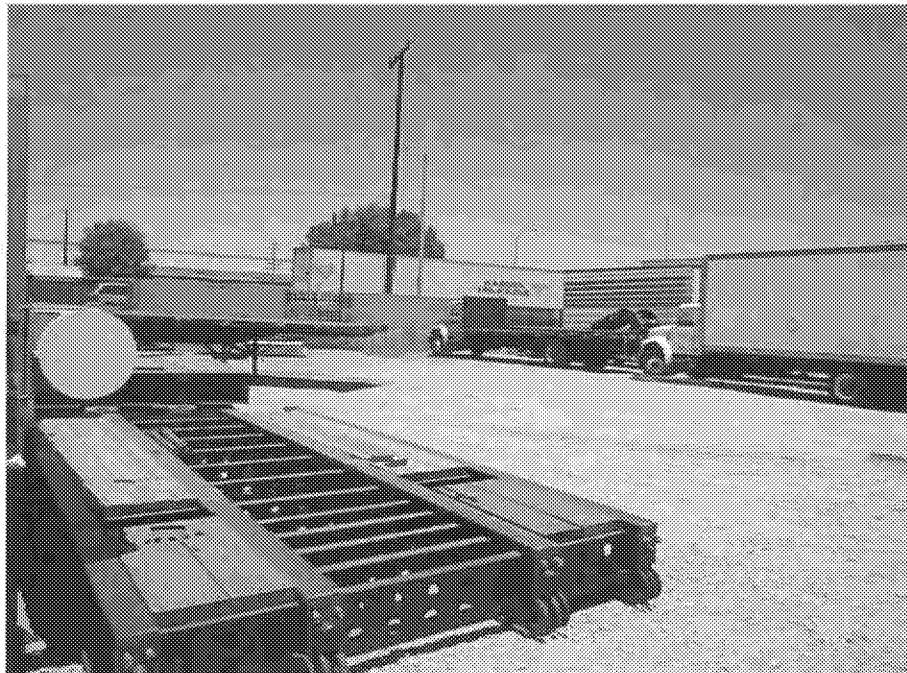
Photograph No. 2 – The area to the east of the building is unpaved and used for truck parking.

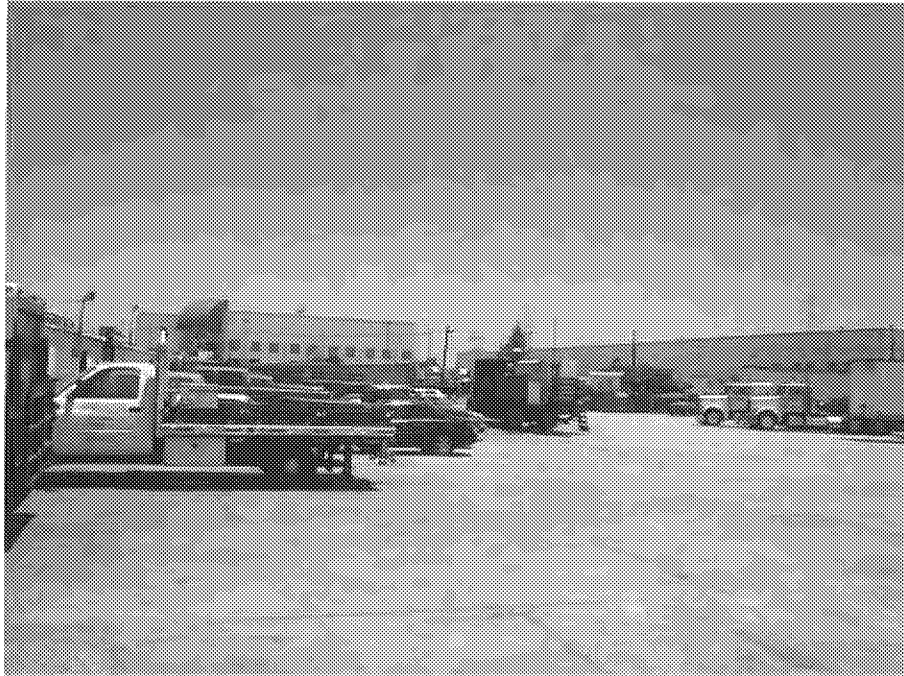
Photograph No. 3 – The main Piazza Trucking facility is located further east of the building.

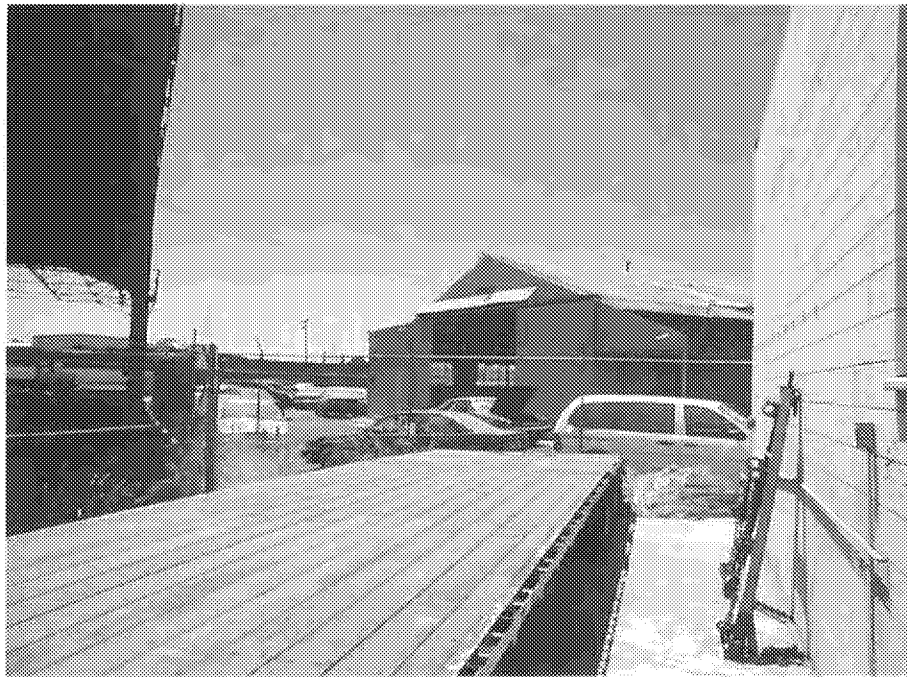
Photograph No. 4 – United Motor Club is located to the west of the property.

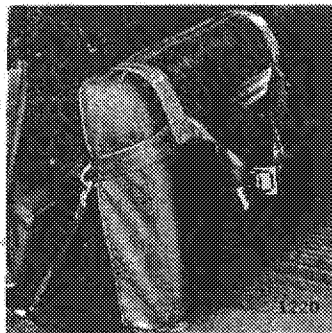
1220 CHEST-TYPE TWO-DOOR SAFETY HARNESS — For installation on two-door cars in which back of individual seat tilts forward. One strap goes horizontally around back of seat, with two straps over top to keep it at desired height, and other strap is fastened around chest, usually just below arms. Provided with retainer strap which attaches with safety-approved bracket, provided, to car floor at rear of seat, and to chest belt to prevent back of seat from tipping forward with occupant during sudden stop or in case of accident. Retainer is hook-fastened to chest belt for easy disengagement to permit entry into rear-seat area. Specify color.

1221 CHEST-TYPE SAFETY HARNESS — Same as preceding 1220 Harness, except does not have retainer strap. For use with late-model cars already equipped with anti-tip device on back of seat.

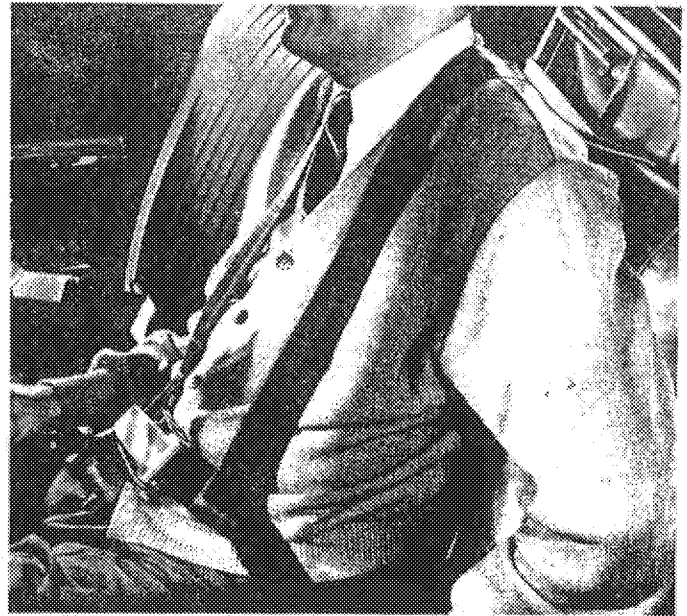
SAFETY HARNESSES — No person — passenger or driver — should ride in a car without being secured by a safety harness. Recent court decisions indicate that a person may not collect personal damages incurred during an automobile accident if he were negligent in utilizing available safeguards. Trujillo Safety Harnesses are designed especially for paraplegics, quadriplegics, and other individuals with limited trunk muscles, to help them maintain an upright and safe position on the car seat. They are made of 2"-wide nylon belting, with a test strength of 5500 pounds, and utilize an aircraft-type safety buckle that is easy to adjust, engage, and disengage. Available in colors of black, brown, green and gray.

1223 SHOULDER-TYPE SAFETY HARNESS — For installation on both two-door and four-door cars. Provides maximum safety during quick stops and in case of accident. Composed of a Y-shaped shoulder belt and a conventional seat belt with aircraft-type buckle. One end of shoulder belt and both ends of seat belt anchor to floor at rear of seat, by means of safety-approved brackets that are provided. Two straps of Y which go over shoulders have loop on end through which seat belt is inserted and then buckled. Specify color.

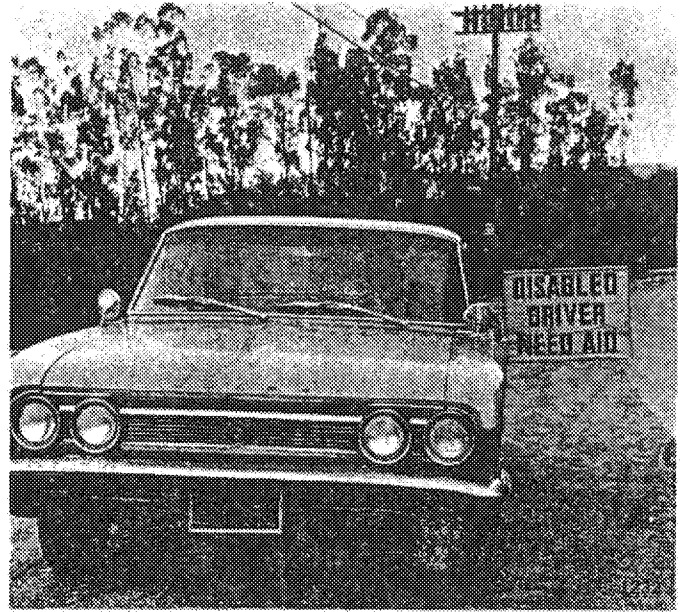
1232 DISABLED DRIVER DISTRESS SIGNAL — No one — whether on country road or 70-mile-per-hour freeway — can miss this distress signal. Black letters on two sides of red fluorescent cloth (16" x 20") can be seen by day or night from both directions. Hanger bracket clips to top of window for display of banner. When not in use, signal folds compactly to fit in protective sleeve, provided, for storage under seat or hanging on dash.

1230 SLIDE BOARD — Permits individuals to slide between car (or bed) and wheelchair. Made of highstrength plywood measuring 12" x 32" on center, with ends rounded and tapered. Thinly cushioned with foam and covered with a black material that provides durable and slick surface to facilitate sliding. Equipped with removable hand loop to enable manipulation by quadriplegics.
